Manhole Inspection Summary

Manhole # S55K__006MH

Insp Date: **9/9/09 10:42 AM**

Location Address: **800 S.Dean St.**

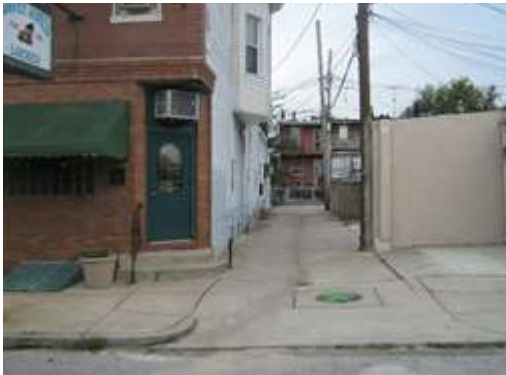
Location View

Facing west

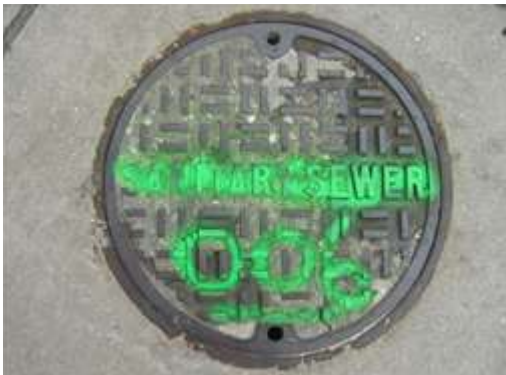
Miscellaneous

MH Lid

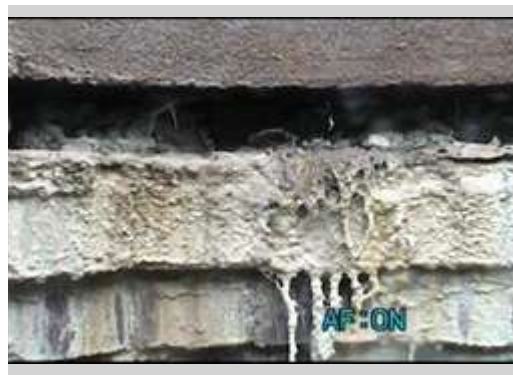
Defect 1

Condition: ☐ Sound ☐ Cracked ☐ Root Intrusion ☐ Loose Brick ☒ **Deteriorated**

deteriorated chimney

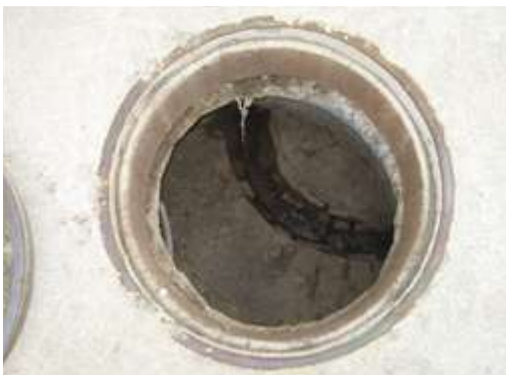
Defect 2

Frame Offset: **1.5** (in.) Condition: ☒ Sound ☐ Cracked ☐ Leaks

frame offset

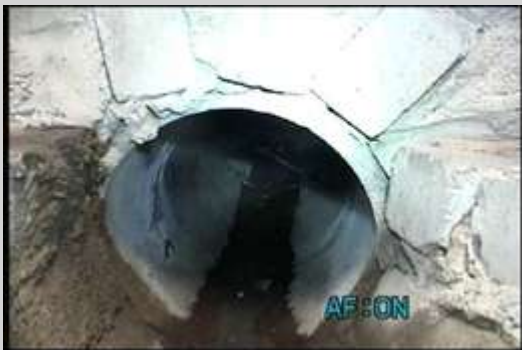
12 O'Clock Outflow

8 in. Circular Gravity Sewer
Pipe Out @ 12 O'Clock

Infiltration: **Evidence** Pipe Seal Cond: **Sound**
